# Microsoft Windows Server 2003, HP Integrity Servers rx8620/rx7620 IMPORTANT SYSTEM INFORMATION

March 2004 (Second Edition)  
Part Number 359991-002

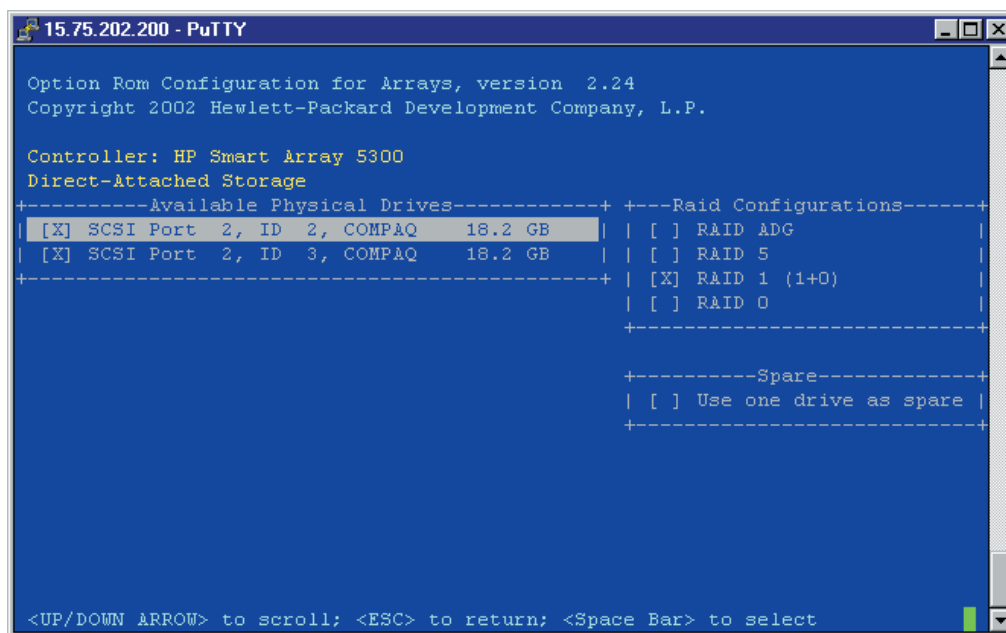
## The Smart Array Option ROM Configuration for Arrays (ORCA) does not prompt the user to press the F8 key during the creation or deletion of a logical drive

**Issue:** When trying to create or delete an array on the Smart Array 6400 controller using the ORCA offline utility, the application does not prompt the user to hit **F8** to create or delete logical drives. The **F8** key is functional, but the prompt is not displayed on the screen (see the screen capture below).

**Workaround:** When configuring an array, press the **F8** key after the physical drives and RAID configuration has been specified to complete array configuration.
